**Flood Control Project Maintenance
Levee Inspections**

Fall 2015 Levee Maintenance Deficiency Summary Report

**Flood Control Project Maintenance
Levee Inspections**
LMA District Cover Sheet
Fall 2015 Levee Inspection Results

Sutter Maintenance Yard East-West Interceptor

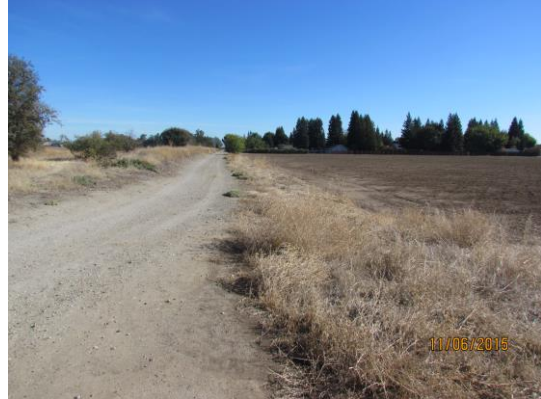
Photo 1 of 1 : FA_2015_ST0020_213_5_20151109_00006.jpg

View of the vegetation along the landslide toe.

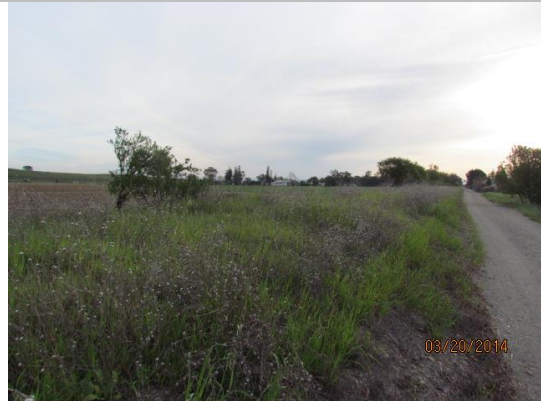
Photo 1 of 1 : FA_2015_ST0020_213_7_20150910_00004.jpg

LM Start	0.00	Rating **	M	Issue No.	7
LM End	0.32	Issue Type +	Ma	Location *	WS
Category	Earthen Levee			GPS Latitude/Longitude	
				Start	End
Item	Vegetation			39.171577 °	39.171481 °
				-121.760019 °	-121.754826 °
DWR ID	DWR_NA0020_01_s _ 2012_7				
Action/Comments					
Remove the wild growth other than native grasses from the levee slopes.

View of the vegetation along the w/s toe.

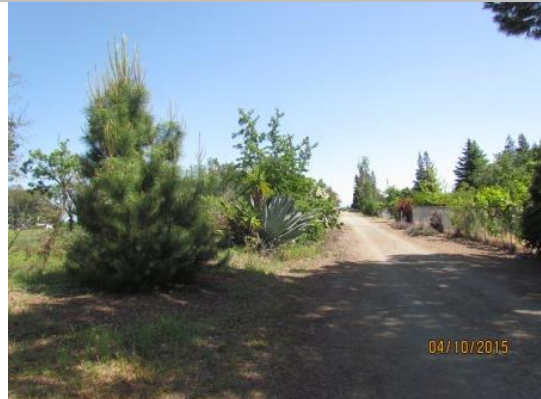
Photo 1 of 2 : FA_2015_ST0020_213_2_20150910_00001.jpg

View of the cactus and pine trees along the waterside berm.

LM Start	0.23	Rating **	M	Issue No.	2
LM End	0.25	Issue Type +	En	Location *	CR
Category	Earthen Levee			GPS Latitude/Longitude	
				Start	End
Item	Vegetation			39.171418 °	39.171408 °
				-121.755963 °	-121.755578 °
DWR ID	DWR_NA0020_01_s _ 2012_2				
Action/Comments					
Landscaping Inspector Comments: Remove the cactus and pine trees from the waterside berm.

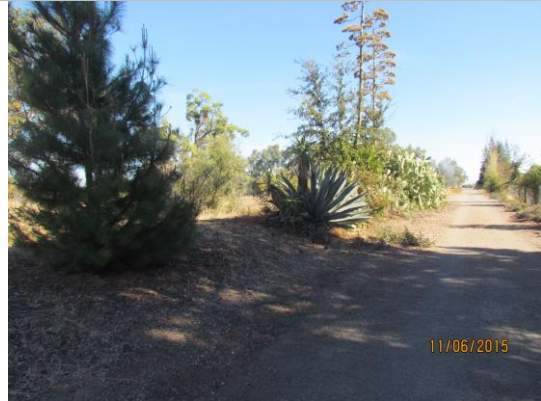
Photo 2 of 2 : FA_2015_ST0020_213_2_20151109_00007.jpg

View of the cactus and pine trees along the waterside berm.

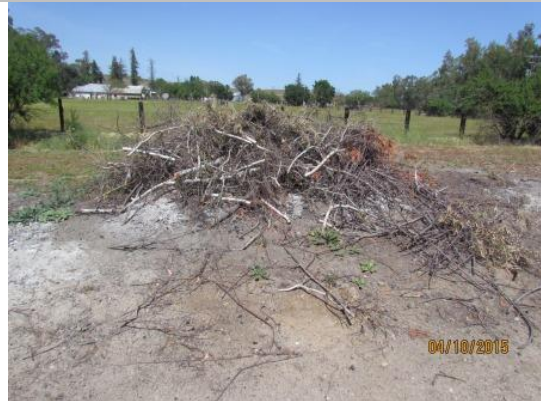
Photo 1 of 1 : FA_2015_ST0020_213_23_20150910_00005.jpg

Remove the prunings from the waterside berm.

LM Start	0.36	Rating **	M	Issue No.	23
LM End	0.36	Issue Type +	En	Location *	CR
Category	Earthen Levee			GPS Latitude/Longitude	
				Start	End
Item	Encroachments			39.171450 °	39.171450 °
				-121.754058 °	-121.754058 °
DWR ID	DWR_NA0020_01_f_2013_23				
Action/Comments					
Prunings					
Inspector Comments: Remove the prunings from the waterside berm.

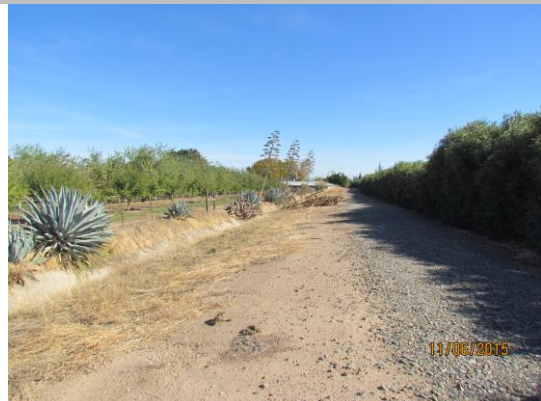
Photo 1 of 1 : FA_2015_ST0020_213_1_20151109_00008.jpg

View of the cactus tree that has fallen on the waterside slope.

LM Start	0.59	Rating **	M	Issue No.	1
LM End	0.59	Issue Type +	En	Location *	WS
Category	Earthen Levee			GPS Latitude/Longitude	
				Start	End
Item	Encroachments			39.171372 °	39.171372 °
				-121.750000 °	-121.750000 °
DWR ID	DWR_ST0020_01_f_2015_1				
Action/Comments					
Tree or limb					
Inspector Comments: Remove the cactus tree from the waterside slope.

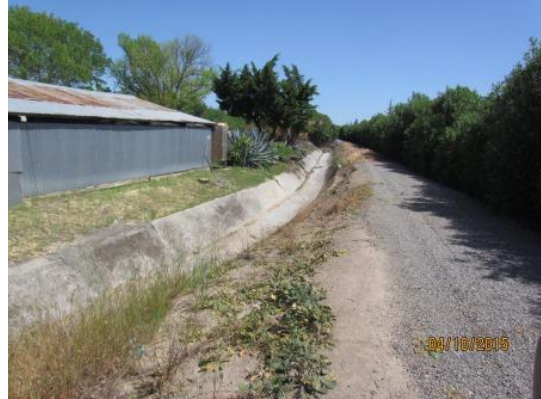
Photo 1 of 2 : FA_2015_ST0020_213_4_20150910_00002.jpg

LM Start	0.62	Rating **	U	Issue No.	4
LM End	0.65	Issue Type +	Ma	Location *	WS
Category	Earthen Levee			GPS Latitude/Longitude	
				Start	End
Item	Erosion / Bank Caving			39.171292 °	39.171232 °
				-121.748868 °	-121.748175 °
DWR ID	DWR_NA0020_01_s _ 2012_4				
Action/Comments					
Schedule repair of erosion site prior to the next inspection.					
Inspector Comments: Repair the erosion along the concrete ditch.

Repair the erosion along the concrete ditch before winter.

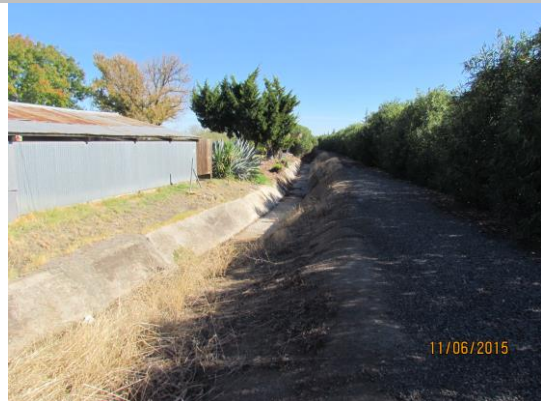
Photo 2 of 2 : FA_2015_ST0020_213_4_20151109_00009.jpg

Repair the erosion along the concrete ditch.

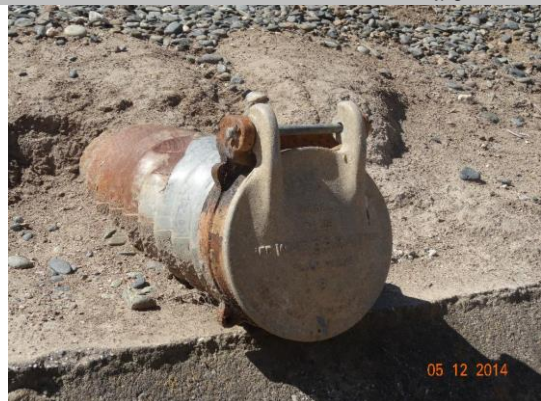
Photo 1 of 2 : UCIP_FA_2015_3914.jpg

LM Start	1.09	Rating **	M	Issue No.	25
LM End	1.09	Issue Type +	En	Location *	WS
Category	Supplemental			GPS Latitude/Longitude	
				Start	End
Item	DWR UCIP Field Study			39.171296 °	39.171296 °
				-121.739779 °	-121.739779 °
DWR ID	DWR_ST0020_01_f _ 2015_25				
Action/Comments					
Inspector Comments: FS_ID:45228					
DS_ID:20115					
EP_NO: N/A					
FS_HLM: 1.085					
Repair Type: Non-Urgent					
Crossing Status: Found

Flapgate installed on WS end.

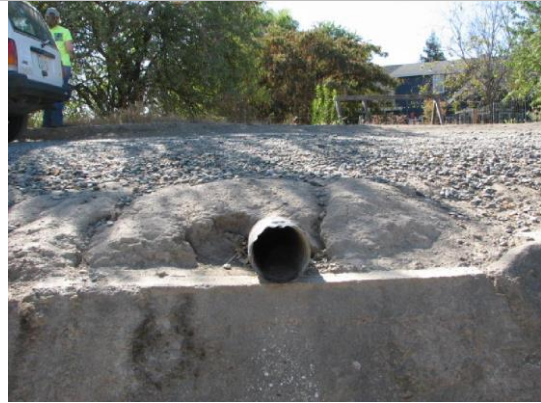
Photo 2 of 2 : UCIP_FA_2015_3915.jpg

LM Start	1.09	Rating **	M	Issue No.	25 (cont)	
LM End	1.09	Issue Type +	En	Location *	WS	
Category	Supplemental			GPS Latitude/Longitude		
				Start	End	
Item	DWR UCIP Field Study			39.171296 °	39.171296 °	
				-121.739779 °	-121.739779 °	
DWR ID	DWR_ST0020_01_f_2015_25					
Action/Comments						
Inspector Comments: FS_ID:45228 DS_ID:20115 EP_NO: N/A FS_HLM: 1.085 Repair Type: Non-Urgent Crossing Status: Found UCIP Comments: 5/12/2015 Crossing appears in good condition. No noticeable issues to report.Pipe not permitted and has no flap gate.5/15/2013 Same as last inspection.11/4/2013 Same as last inspection.5/12/2014 New flapgate installed on WS pipe end.11/17/2014 Same as last inspection. FIELD_STRUCT_DESC: 8-inch corrugated metal drain pipe through the levee 1.5-feet below the crown. Unable to locate the inlet. FS Date: 05/14/2015

Pipe at outlet on WS crown.

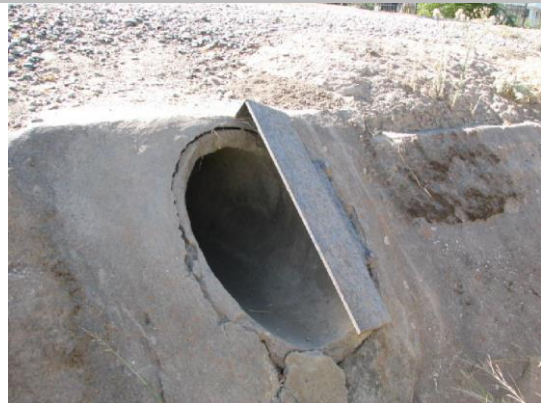
Photo 1 of 1 : UCIP_FA_2015_5641.jpg

LM Start	1.09	Rating **	U	Issue No.	26
LM End	1.09	Issue Type +	En	Location *	WS
Category	Supplemental			GPS Latitude/Longitude	
				Start	End
Item	DWR UCIP Field Study			39.171301 °	39.171301 °
				-121.739799 °	-121.739799 °
DWR ID	DWR_ST0020_01_f_2015_26				
Action/Comments					
Inspector Comments: FS_ID:45227 DS_ID:19434 EP_NO: 12746 FS_HLM: 1.085 Repair Type: Urgent Crossing Status: Found UCIP Comments: 5/12/2015 Still no flap gate on pipe end but i believe the LS inlet is high enough to not allow water to flow through pipe. There is no flap gate or other device to prevent water from flowing back through the pipe at the outlet. 5/15/2013 Same as last inspection. 11/4/2013 Same as last inspection. 5/12/2014 Same as last inspection. 11/17/2014 Same as last inspection. FIELD_STRUCT_DESC: 24-inch concrete storm drain pipe through the levee 2-feet below the crown with a steel deflector at outlet. (Permit No. 12746, 1979, Garcia). FS Date: 05/14/2015

Outlet in channel with steel deflector over pipe outlet.

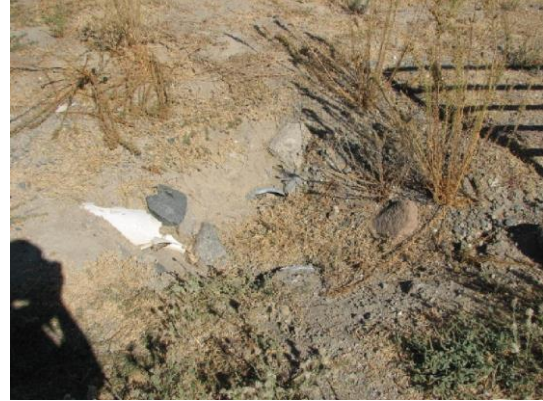
Photo 1 of 3 : UCIP_FA_2015_5642.jpg

Inspector Comments: FS_ID:45230
 DS_ID:19432
 EP_NO: 15946
 FS_HLM: 1.34
 Repair Type: Non-Urgent
 Crossing Status: Found
 UCIP Comments: 5/12/2015 LS inlet is still completely blocked with soil. Inlet is completely blocked with soil. 5/15/2013 Same as last inspection. 11/4/2013 Same as last inspection. 5/12/2014 Same as last inspection. 11/17/2014 Same as last inspection.
 FIELD_STRUCT_DESC: 12-inch CMP drain line through the levee 2-feet below the crown encased in concrete with flap gate on water side.
 Permit No. 15946 (1992) Design drawings available in permit.
 FS Date: 05/14/2015

Soil filled inlet on LS of crown.

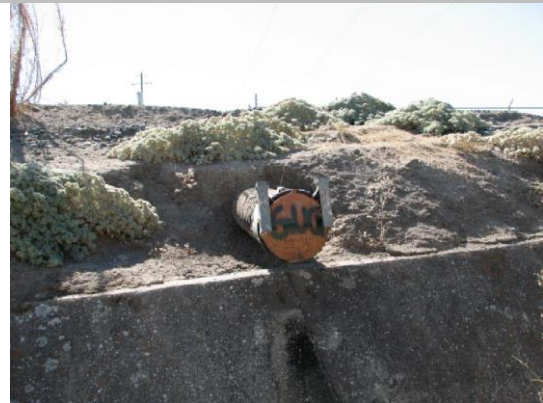
Photo 2 of 3 : UCIP_FA_2015_5643.jpg

Flap gate and pipe at canal.

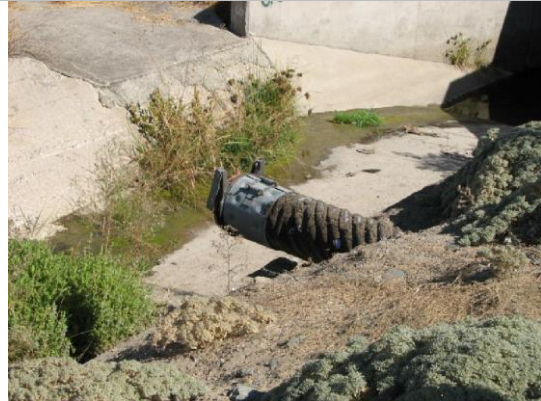
Photo 3 of 3 : UCIP_FA_2015_5644.jpg

Coated CMP at outlet.

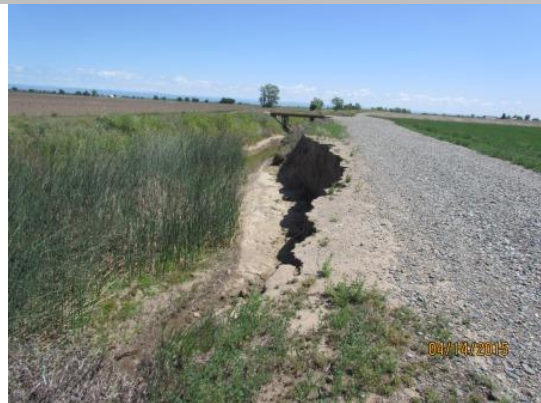
Photo 1 of 2 : FA_2015_ST0020_213_6_20150910_00003.jpg

LM Start	1.67	Rating **	U	Issue No.	6
LM End	1.67	Issue Type +	Ma	Location *	WS
Category	Rivers, Channels & Designated Floodways			GPS Latitude/Longitude	
				Start	End
Item	Erosion / Bank Caving			39.171128 °	39.171128 °
				-121.729235 °	-121.729235 °
DWR ID	DWR_NA0020_01_s_2012_6				
Action/Comments					
Inspector Comments: Sutter Yard needs to repair the erosion before winter.

Repair the erosion along the waterside slope.

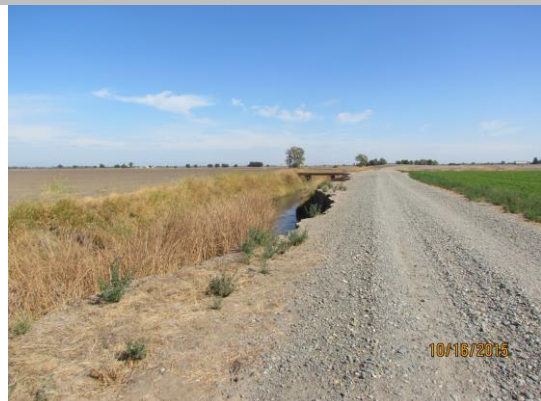
Photo 2 of 2 : FA_2015_ST0020_213_6_20151109_00010.jpg

Repair the erosion along the waterside slope.

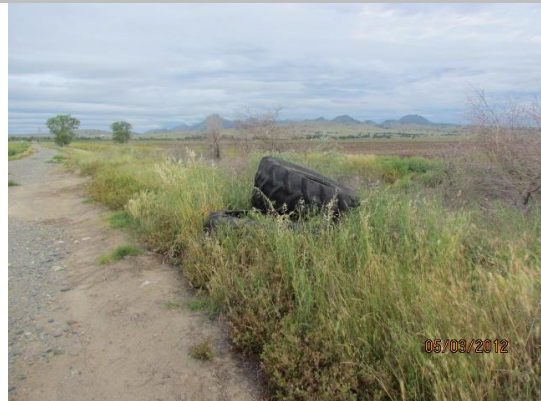
Photo 1 of 1 : FA_2015_ST0020_214_12_20150910_00009.jpg

View of the tires along the W/S toe.

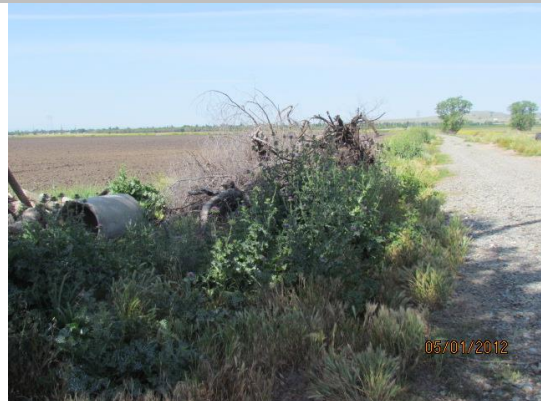
Photo 1 of 1 : FA_2015_ST0020_214_9_20150910_00007.jpg

LM Start	0.26	Rating **	M	Issue No.	9
LM End	0.26	Issue Type +	En	Location *	LS
Category	Earthen Levee			GPS Latitude/Longitude	
				Start	End
Item	Encroachments			39.171101 °	39.171101 °
				-121.721856 °	-121.721856 °
DWR ID	DWR_NA0020_02_s _ 2012_9				
Action/Comments					
Debris

View of the debris along the L/S toe.

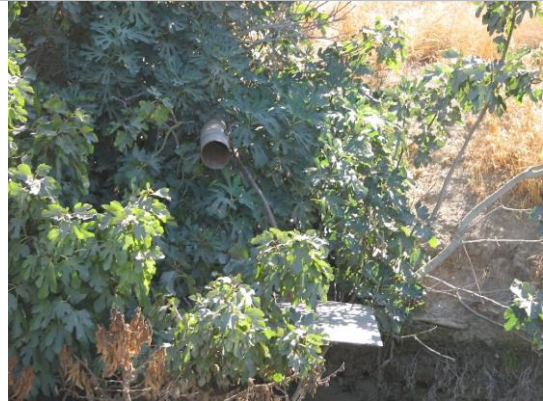
Photo 1 of 3 : UCIP_FA_2015_3513.jpg

Inspector Comments: FS_ID:45244
 DS_ID:19425
 EP_NO: N/A
 FS_HLM: 0.39
 Repair Type: Non-Urgent
 Crossing Status: Found
 UCIP Comments: 5/12/2015 Abandoned crossing. Pipe and pump abandoned. Pipe should be removed or properly abandoned. 5/15/2013 Same as last inspection. 11/4/2013 Same as last inspection. 5/12/2014 Same as last inspection. 11/17/2014 Same as last inspection.
 FIELD_STRUCT_DESC: 8-inch iron irrigation pipe through the levee 2-feet below crown. 7.5 HP Pump in canal. Originally included in O+M manual 1953. See As-builts Dwg. 50-10-2816.
 FS Date: 05/14/2015

View of pipe from unprotected side of levee.

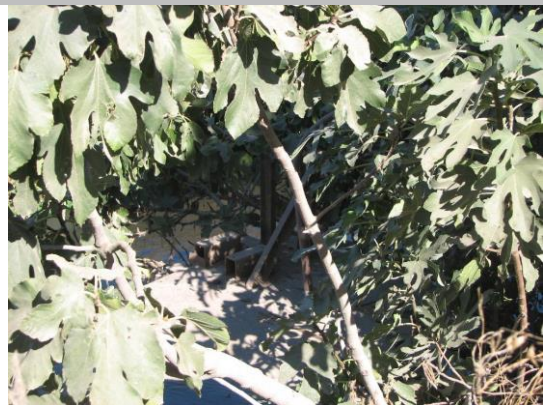
Photo 2 of 3 : UCIP_FA_2015_3514.jpg

Pump platform on LS slope.

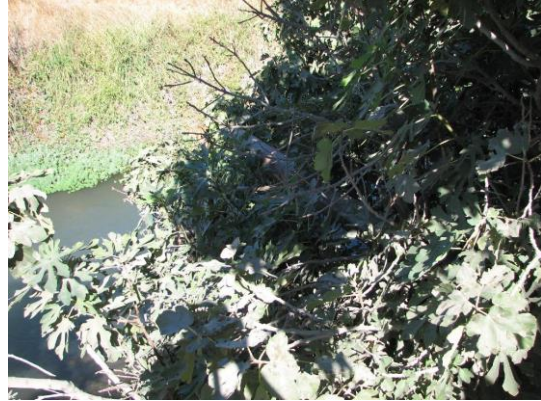
Photo 3 of 3 : UCIP_FA_2015_3515.jpg

Pipe on LS slope.

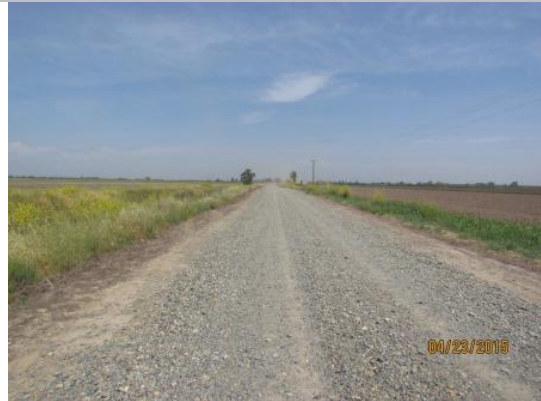
Photo 1 of 2 : FA_2015_ST0020_214_2_20150910_00002.jpg

LM Start	0.55	Rating **	M	Issue No.	2
LM End	2.72	Issue Type +	Ma	Location *	WS
Category	Earthen Levee			GPS Latitude/Longitude	
				Start	End
Item	Vegetation			39.171002 °	39.170507 °
				-121.716293 °	-121.676212 °
DWR ID	DWR_NA0020_02_s_2012_2				
Action/Comments					
Remove the wild growth other than native grasses from the levee slopes.					
Inspector Comments: Remove the vegetation from both slopes.

View of the vegetation on both slopes.

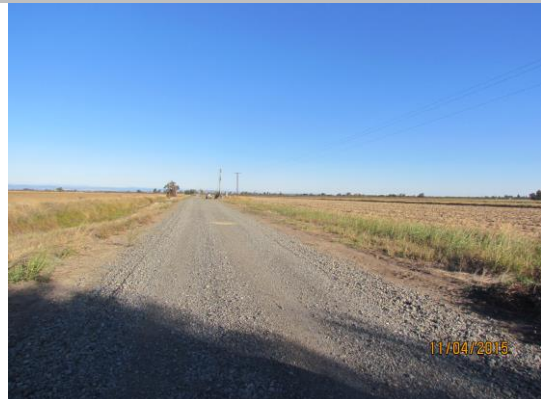
Photo 2 of 2 : FA_2015_ST0020_214_2_20151109_00014.jpg

View of the vegetation on both slopes.

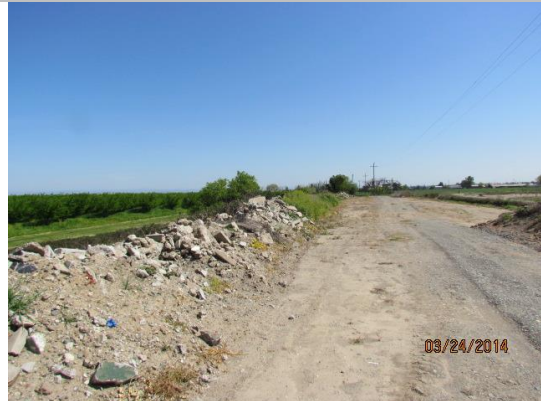
Photo 1 of 2 : FA_2015_ST0020_214_3_20150910_00003.jpg

LM Start	1.43	Rating **	M	Issue No.	3
LM End	1.55	Issue Type +	Ma	Location *	LS
Category	Earthen Levee			GPS Latitude/Longitude	
				Start	End
Item	Encroachments			39.170782 °	39.170817 °
				-121.700167 °	-121.698203 °
DWR ID	DWR_NA0020_02_s_2012_3				
Action/Comments					
Debris					
Inspector Comments: Remove the broken concrete.

View of the piles of broken concrete.

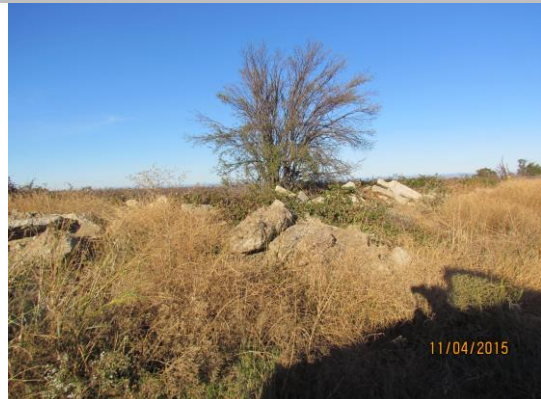
Photo 2 of 2 : FA_2015_ST0020_214_3_20151109_00015.jpg

View of the pile of broken concrete.

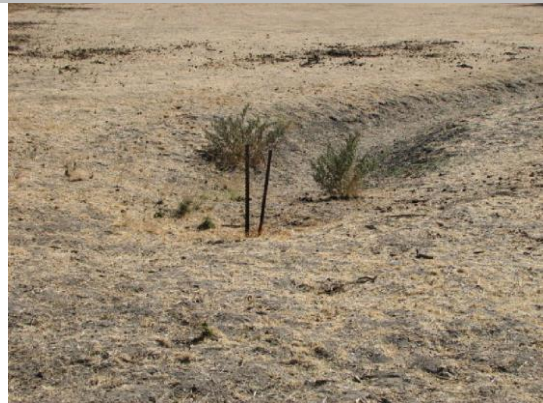
Photo 2 of 2 : UCIP_FA_2015_3560.jpg

Burried inlet 30 feet from LS shoulder.

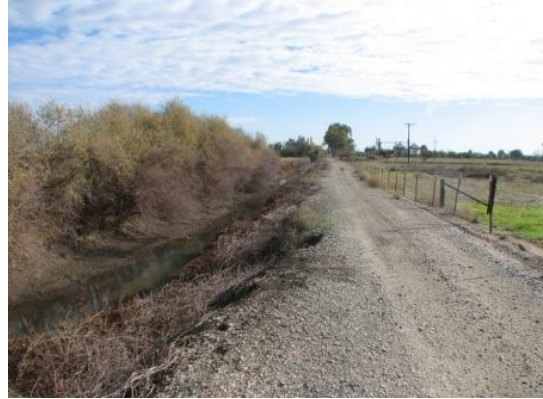
Photo 1 of 2 : FA_2015_ST0020_214_4_20150910_00004.jpg

View of the erosion along the waterside slope.

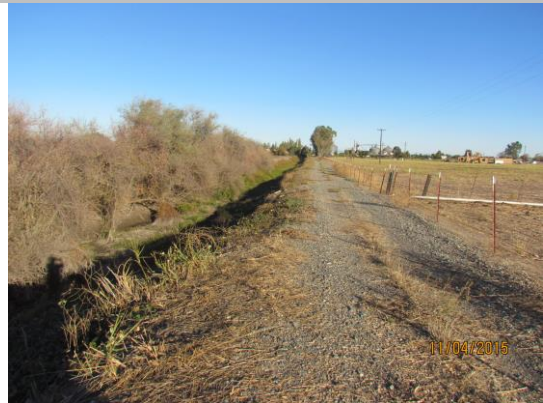
Photo 2 of 2 : FA_2015_ST0020_214_4_20151109_00016.jpg

View of the erosion along the waterside slope.

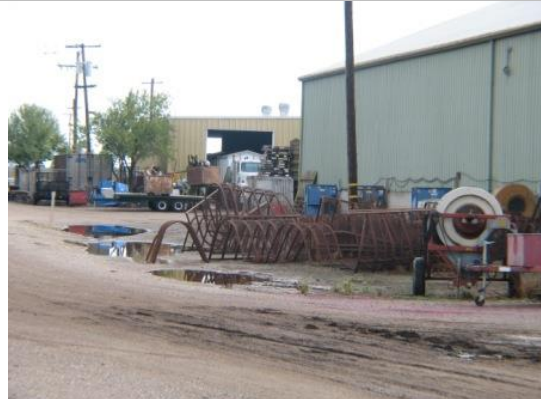
Photo 1 of 1 : FA_2015_ST0020_214_5_20150910_00005.jpg

View of the equipment and buildings next to the landside berm.

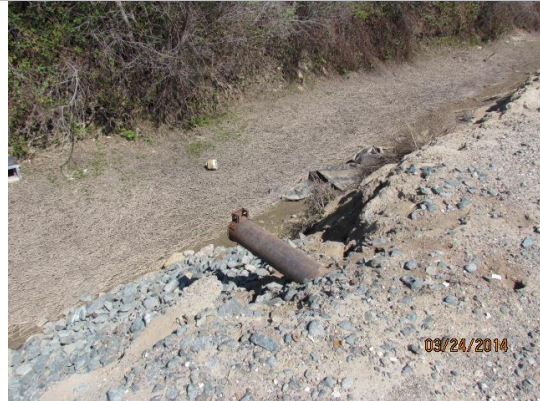
Photo 1 of 1 : FA_2015_ST0020_214_26_20150910_00012.jpg

View of the unauthorized pipe going through the crown of the levee.

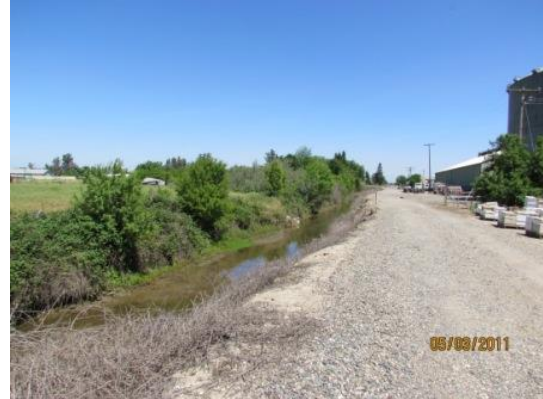
Photo 1 of 1 : FA_2015_ST0020_214_6_20150910_00006.jpg

View of the erosion along the W/S slope.

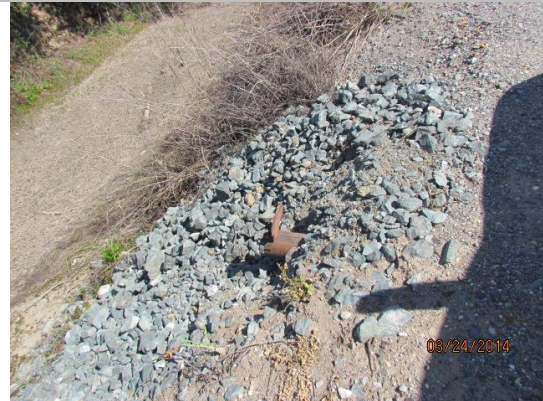
Photo 1 of 1 : FA_2015_ST0020_214_27_20150910_00013.jpg

View of the unauthorized pipe going through the crown of the levee.

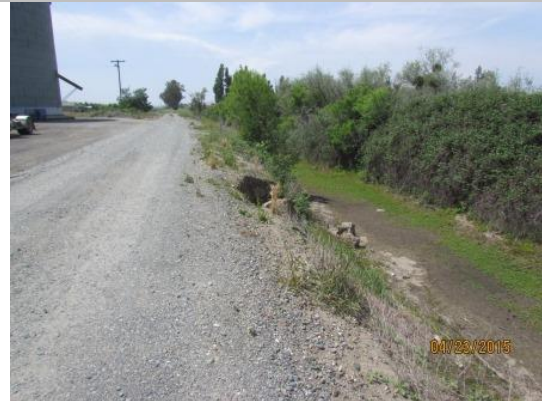
Photo 1 of 1 : FA_2015_ST0020_214_17_20150910_00010.jpg

View of the erosion along the waterside slope.

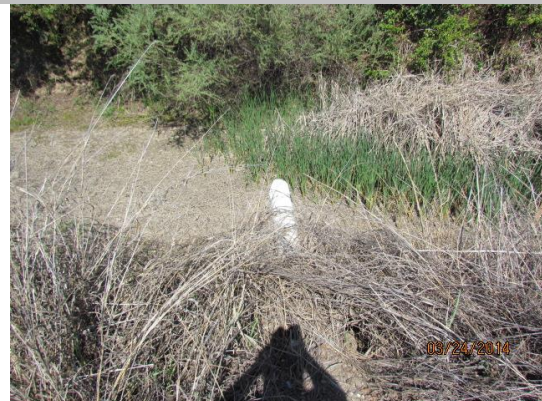
Photo 1 of 1 : FA_2015_ST0020_214_18_20150910_00011.jpg

View of the unauthorized pipe going through the crown of the levee.

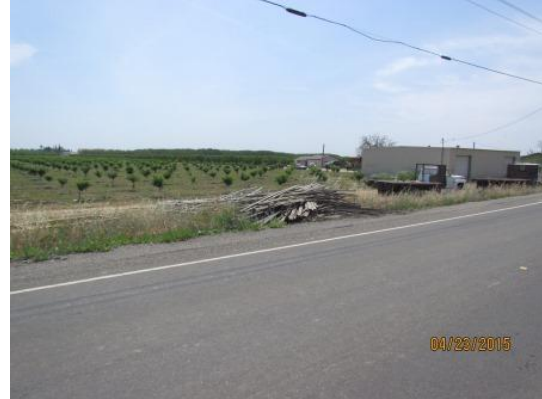
Photo 1 of 1 : FA_2015_ST0020_214_10_20150910_00008.jpg

View of the material, garbage and equipment along the landside toe

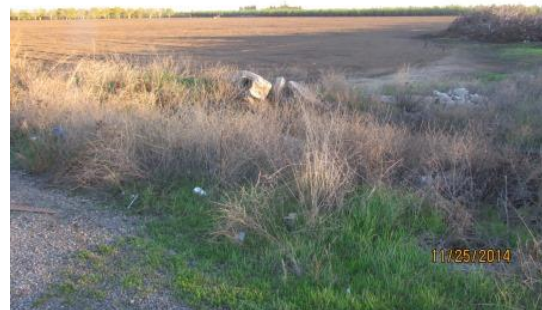
Photo 1 of 1 : FA_2015_ST0020_214_1_20150910_00001.jpg

View of the concrete along the landside toe.
